July 9, 2011
PAC Meeting

J-PARC Status

J-PARC Center

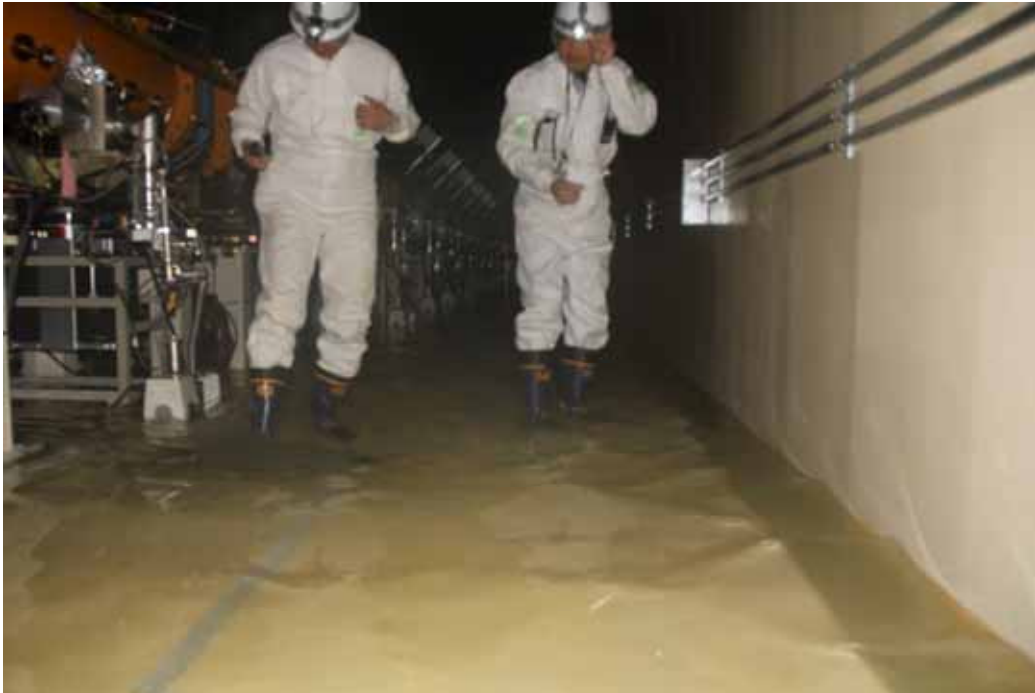
Linac Tunnel as of March 24

On March 17 the water level was only 1 cm, but it increased to 10 cm (100 tons) on March 24. The water was pumped out with an in-house electric generator, and the problems were resolved afterwards.

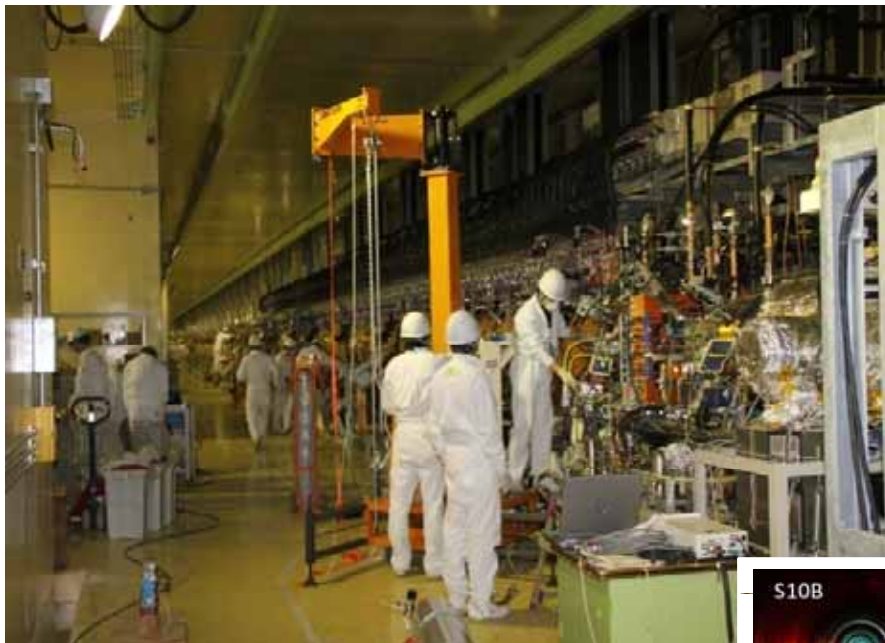
Floor sagged ~4 cm in the middle. However, other places, except beam monitors, were normal. (Beam was aligned step by step through repetition of dropping the beam power and being bent by magnets. A perfect alignment is planned in the next year.)

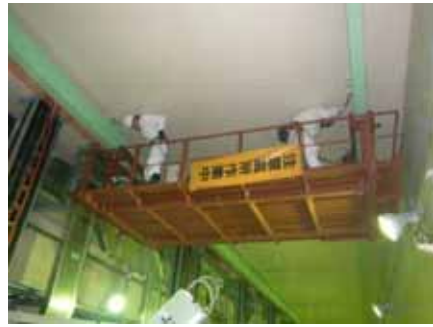
Inspection of crane in the tunnel

Confirming it can be operated with a weight limit.

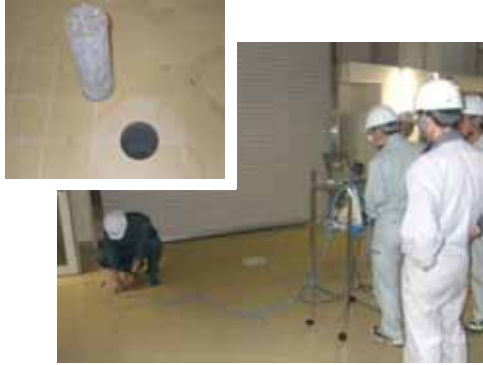
Close inspection of substructure of building with impact elastic wave method and taking cores

~80 cm void was found. The repair plan is discussed. Floor leveling is also investigated.

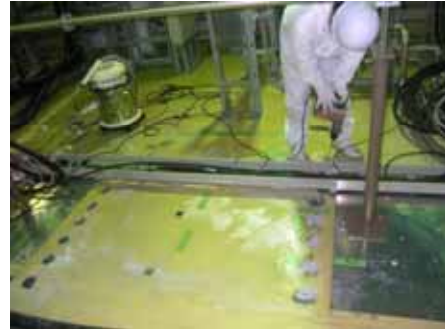
Repair of water leaks in the tunnel

The leakages were stopped by injection of a foaming urethane material.

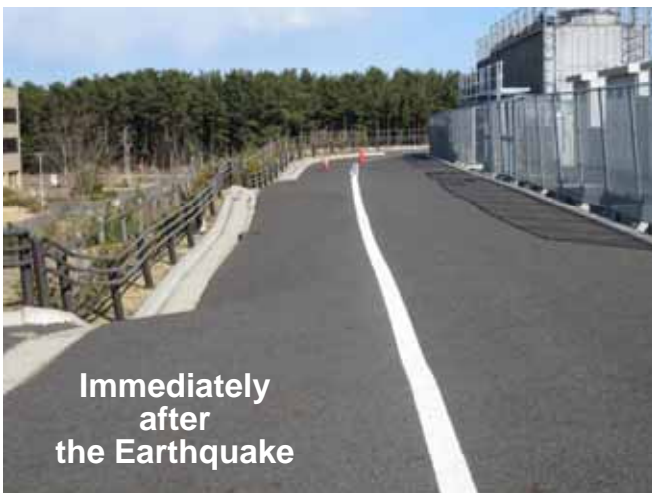
Immediately after the Earthquake

Wavy road!

The beam pipe was present underneath a bump in the middle. Both sides were sinking.

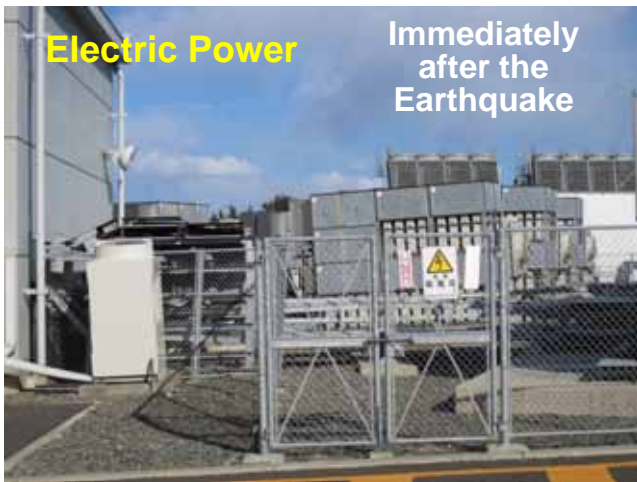
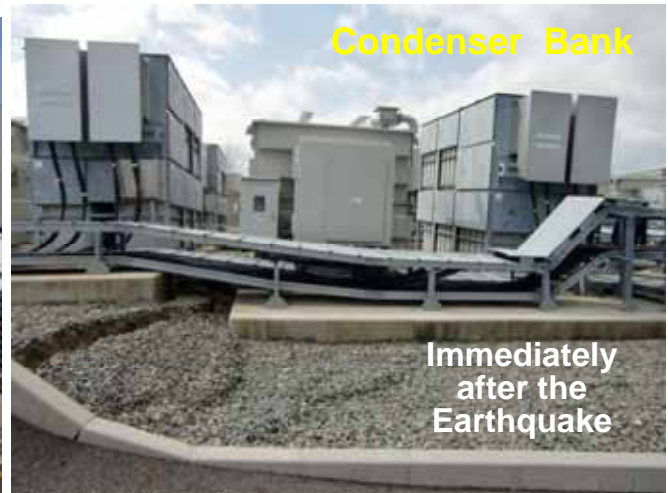
Leaned to the left.

Around the building entrance, approximately 100 cables had been buried, and all of them were distorted.

A condenser (capacitor) bank was waved. Cables were distorted due to its weight.

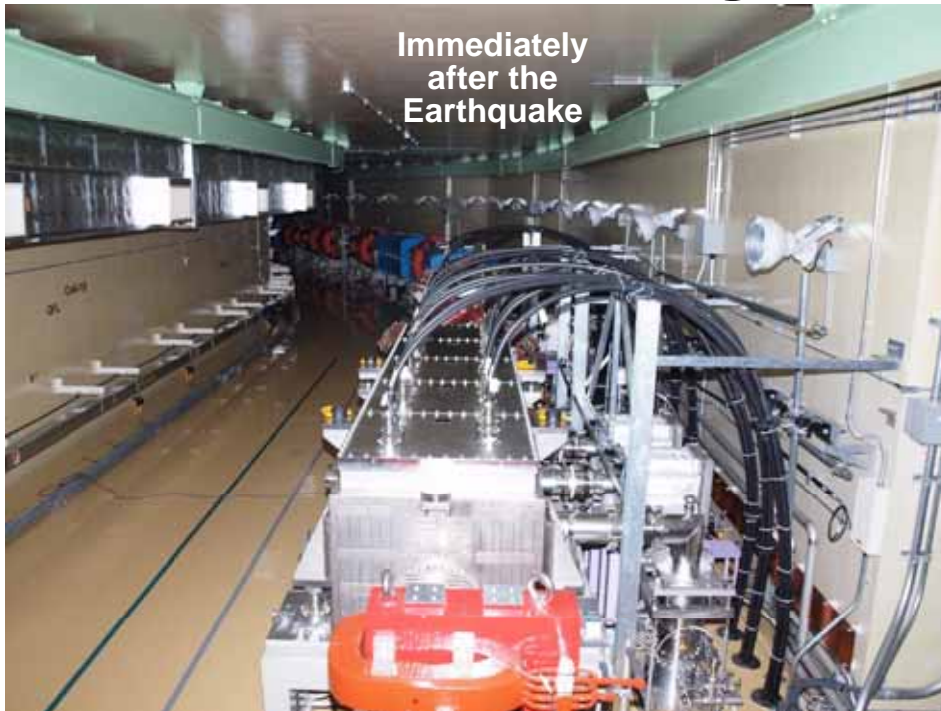
3 GeV Main Ring

No obvious damages were observed.
(Photo taken on March 29)

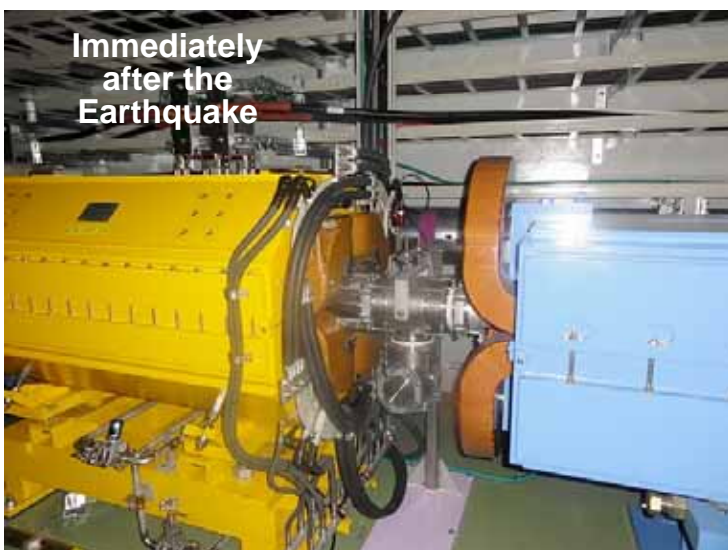
50 GeV Main Ring

No damages were observed through an inspection from the outside alone.
(Photo taken on March 17)

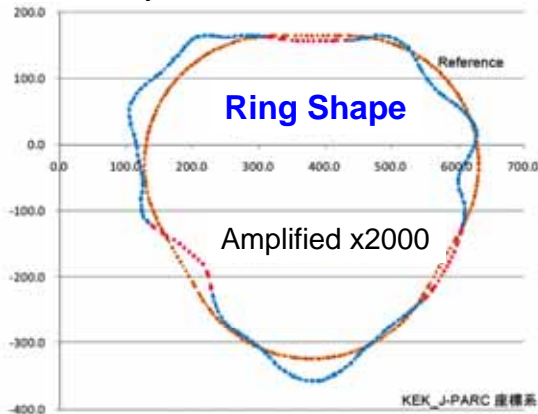
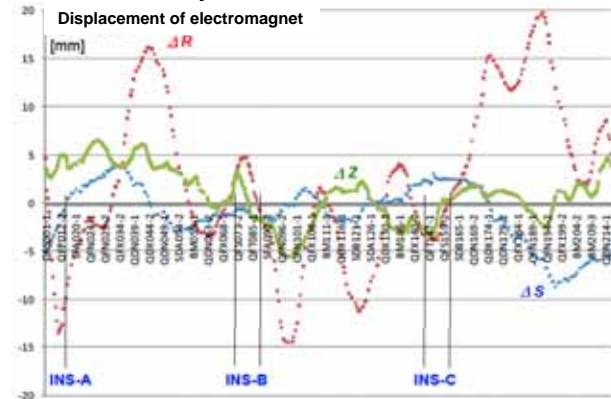
Preliminary Results of Circumference Measurement by Laser Trucker

- It appeared there was a large misalignment in both horizontal and vertical directions.
- ~20 electromagnet mounts shifted more than a limit of simple adjustment.
- All electromagnets will be realigned. Three teams will be done between August and October.

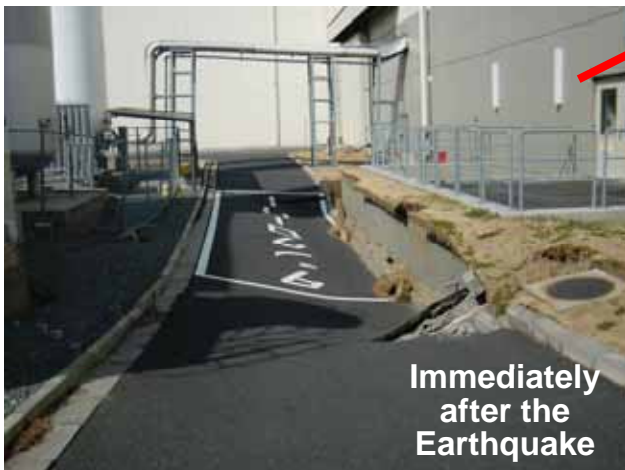
Immediately after the Earthquake
Road at the west side of the MLF building felled in ~1.5 m

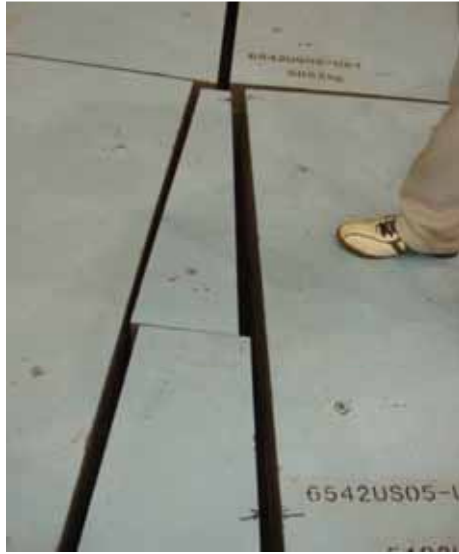
Displacement of shielding walls in MLF
1st Hall: BL04 Area (left)
2nd Hall: BL20 Area (right top)

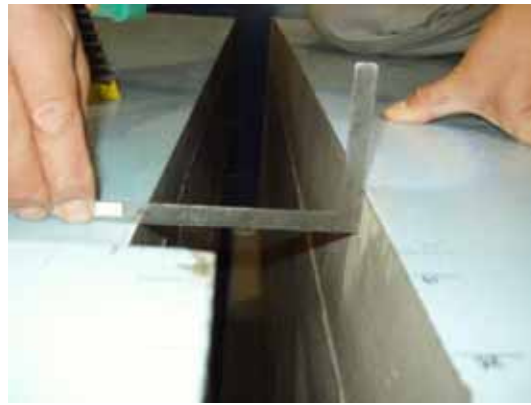
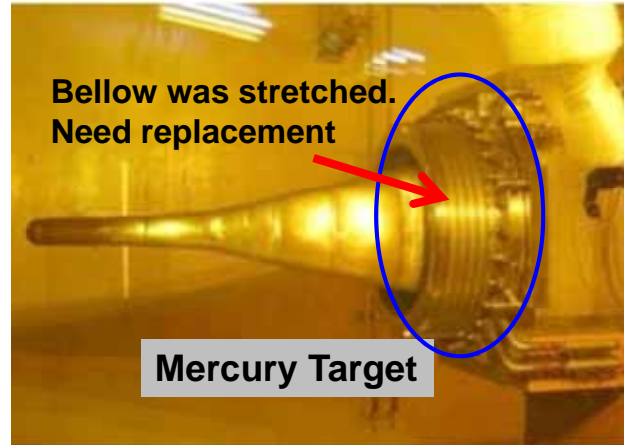
Bellow of the target shifted ~30 cm.
Replacement is planned.

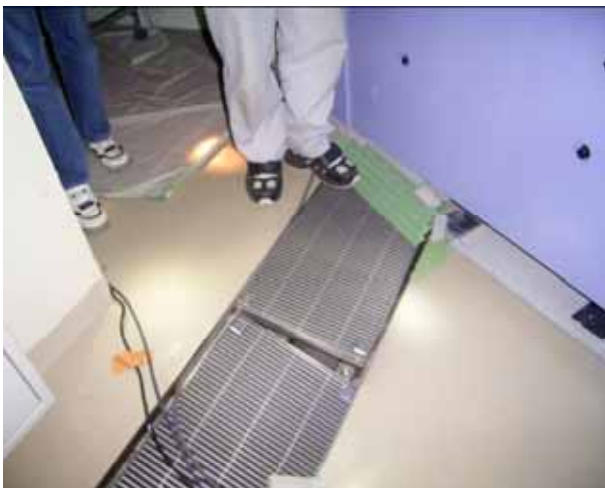
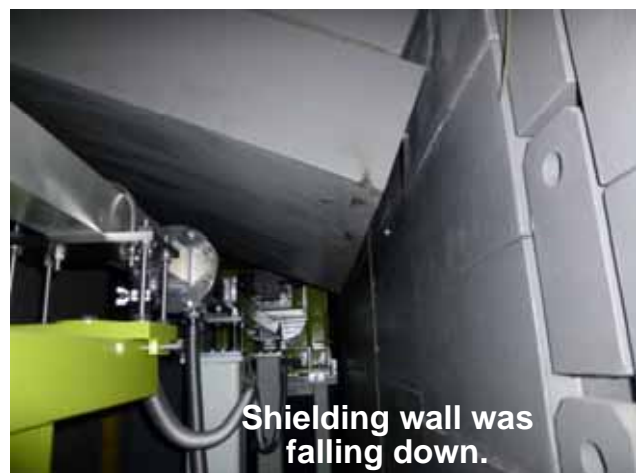
A 30 cm gap between the MFL and the west-side added building (left)
 BL18, BL19 and BL20 were damaged.
 Dropped shield (right)
 The repair has been already completed.

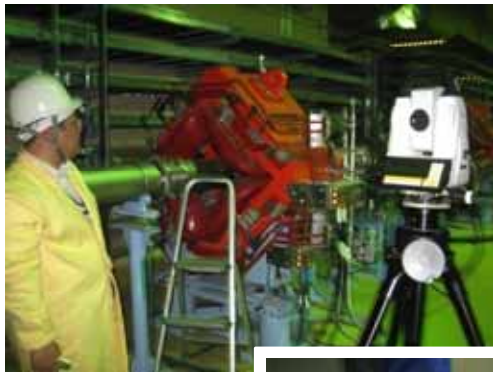
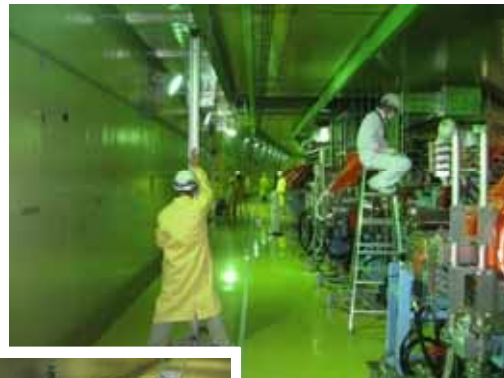
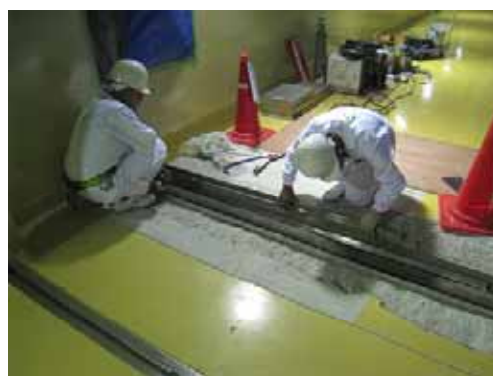
MLF sagged, being 12 mm lower compared to RCS (3 GeV synchrotron).

Mending cracks of walls and floors by injection of plastics

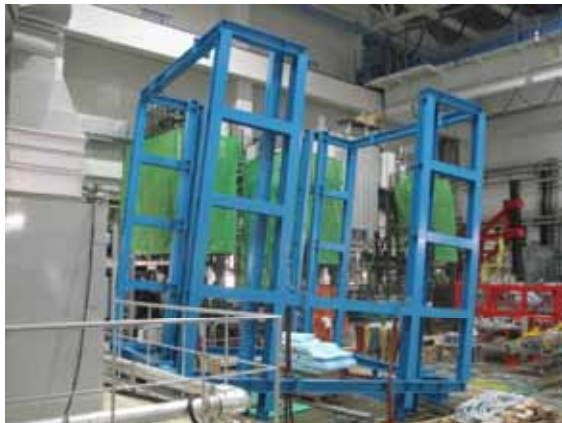
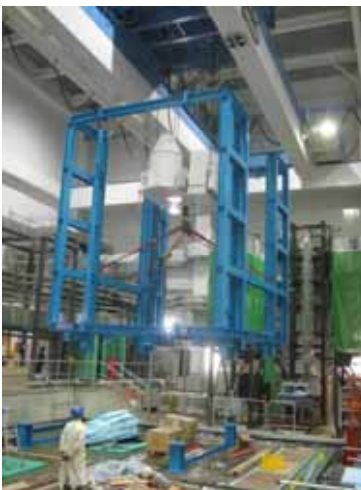
Remote
maintenance
guide cell for
Neutrino
Horn
Very
dangerous
situation, but
it was
repaired
(below).

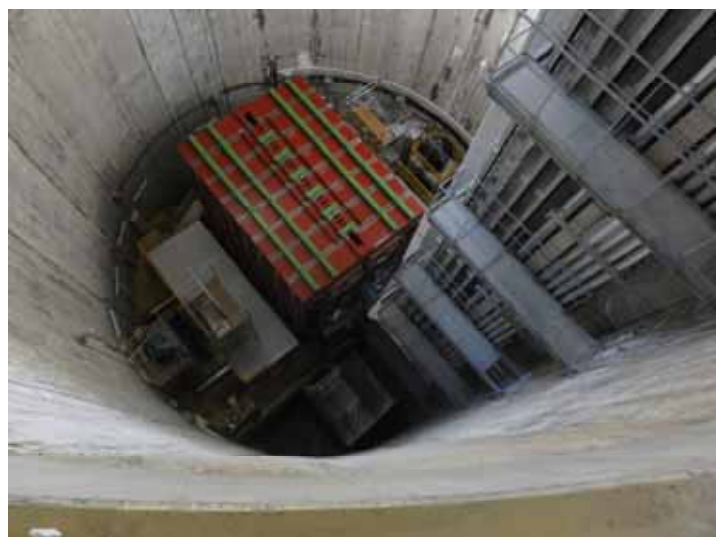
Guiderail for the Horn and On Site Detector

No significant damages through outside
inspection. About 1 cm deep water at the bottom.
This problem has been already solved.

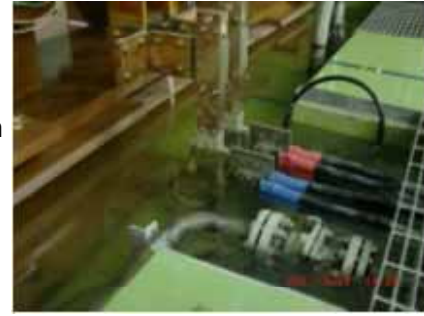
- There are no serious damages. A sealing efficiency of superconductivity magnet has been also confirmed though conducting current test.
- Submerged cables and connectors will be replaced.
- 31 out of 35 magnets will be realigned.

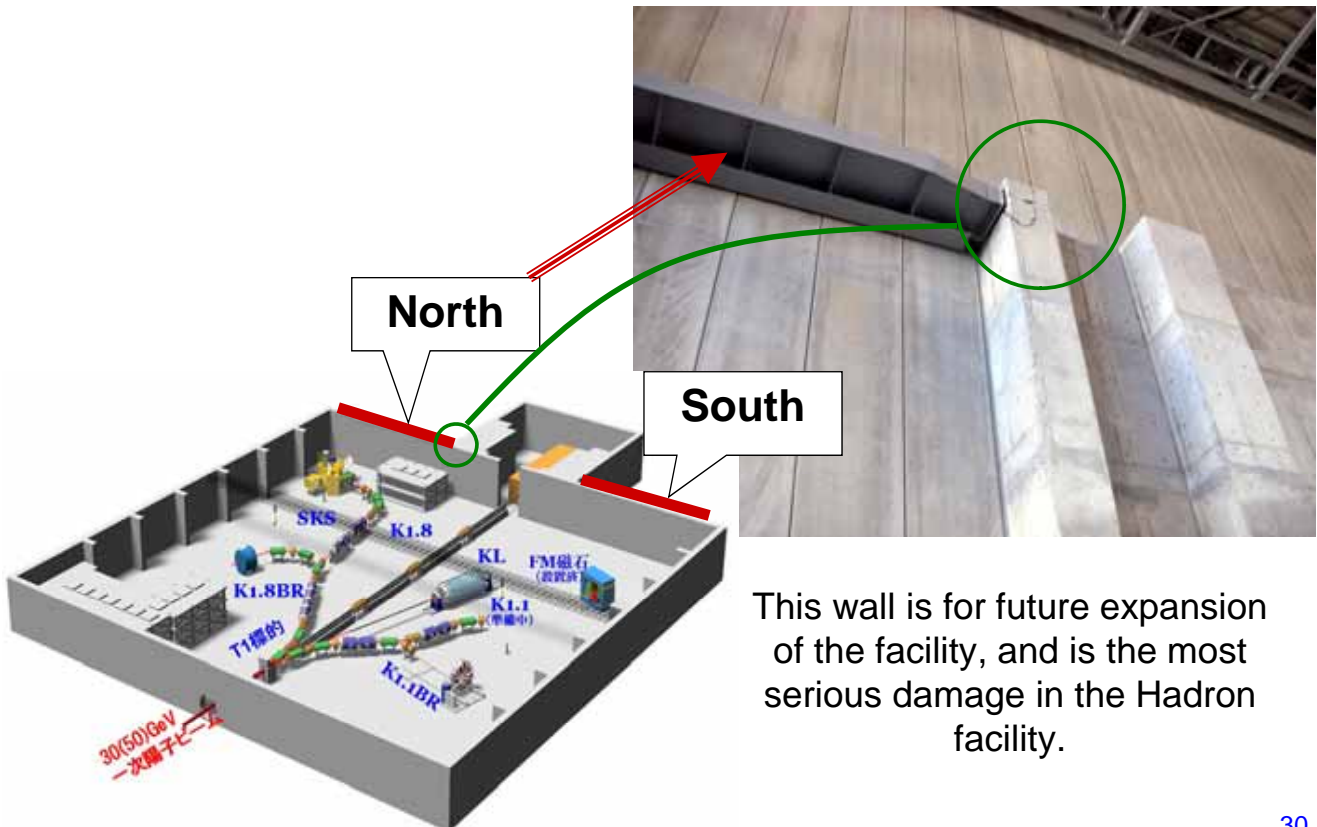
Outside Wall of the Hadron Hall

This wall is for future expansion of the facility, and is the most serious damage in the Hadron facility.
