# Status of the SKS spectrometer and Experiments at K1.8

J-PARC 12<sup>th</sup> PAC

# ***The effect of the Earthquake (Summary)***

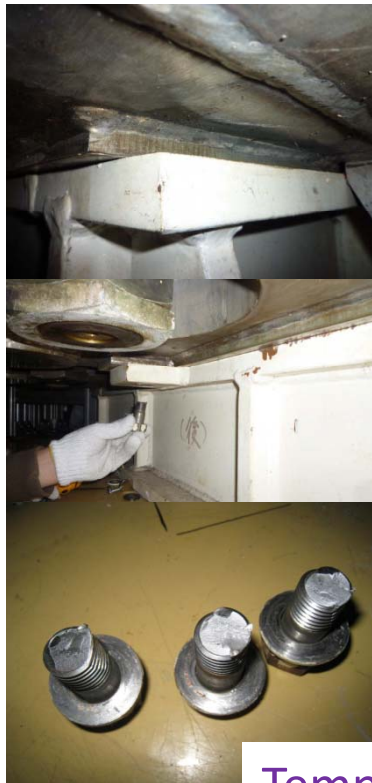
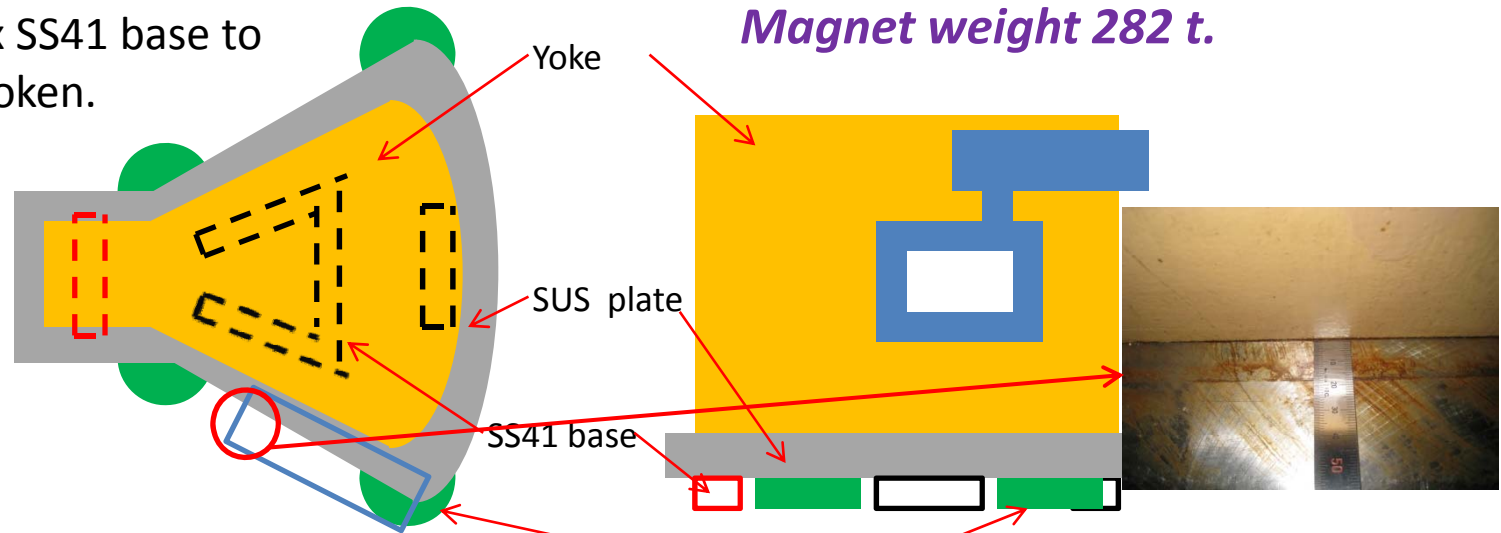
6 bolts (M20) to fix SS41 base to SUS plate were broken.

10-30mm displacement between SS41 base and SUS plate.

Temporary, SS41 base will be fixed to SUS plate by welding or hanging mechanically with chain clamps.

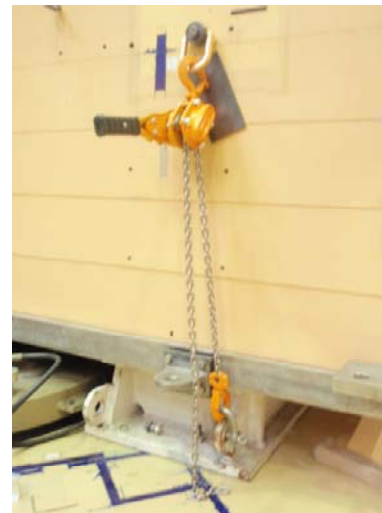
Yoke slipped by 18mm on the SUS plate.

No recovery. Precise measurements of the position will be taken into the analysis.

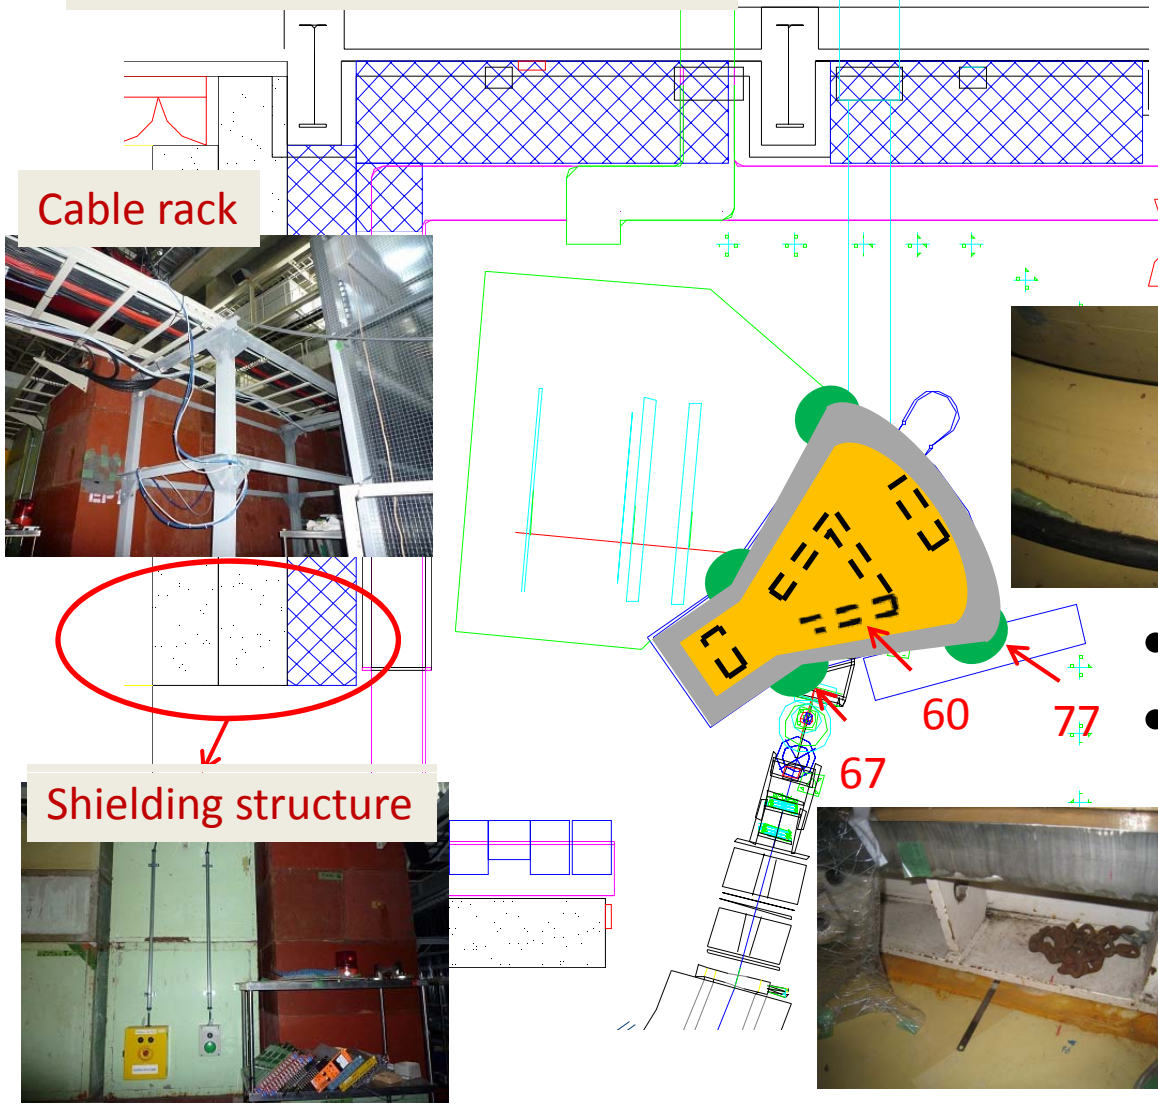
Displacement to the floor (mm)

• SKS magnet was moved from the normal position.

set to the normal position

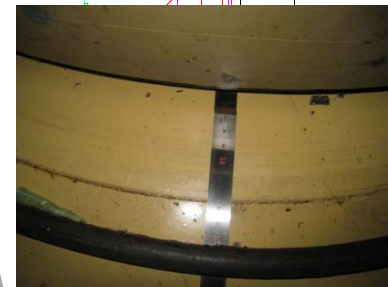
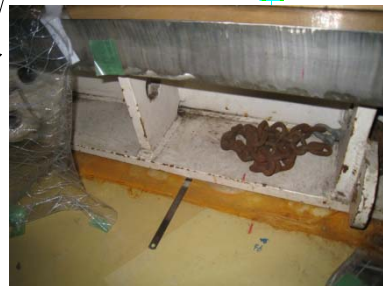
• Floor sinks by 1-2mm  
• Beam height  $\neq$  Mid-plane

No recovery.  
Precise measurements of the position will be taken into the analysis.

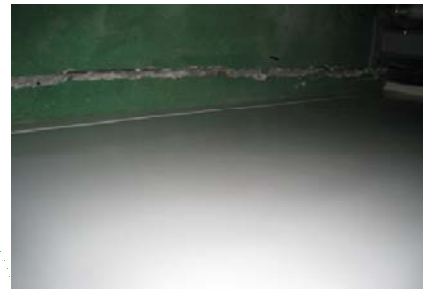
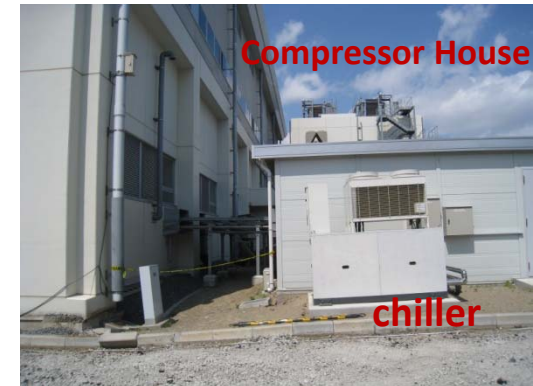
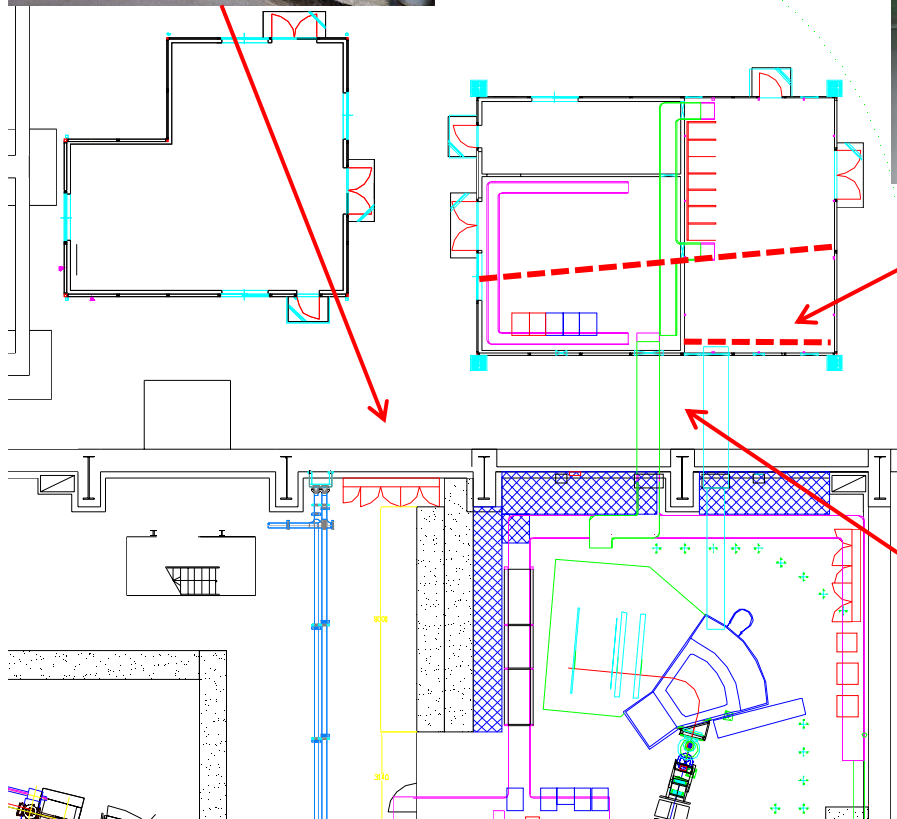
Cracks on the base of Counting Hut & Compressor House

- Part of floor inclines.

Large crack along the wall

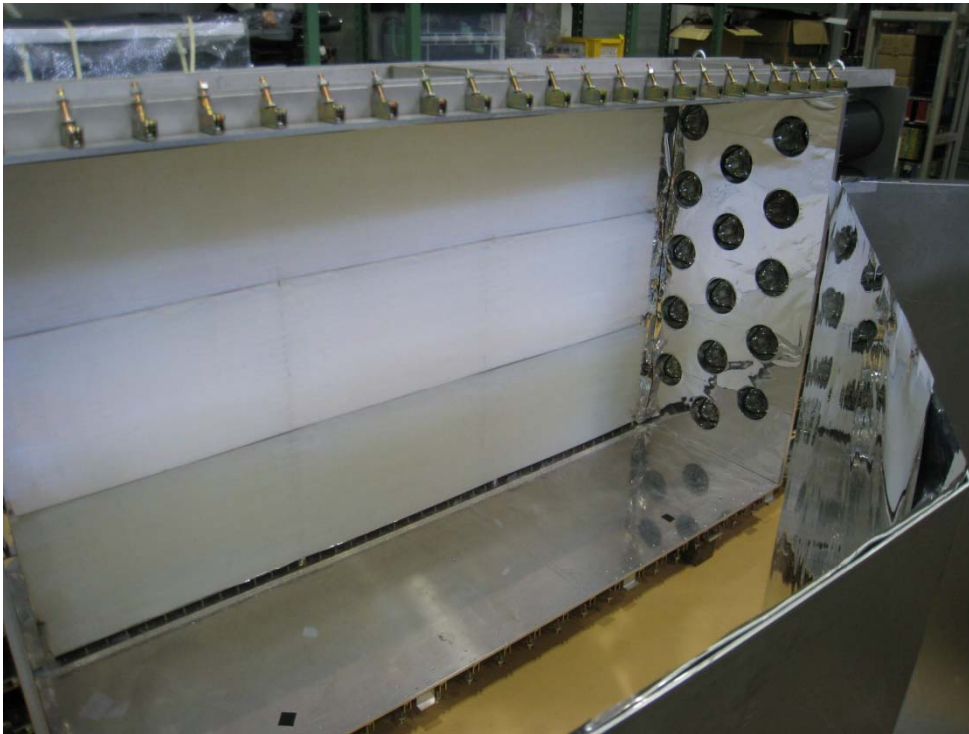
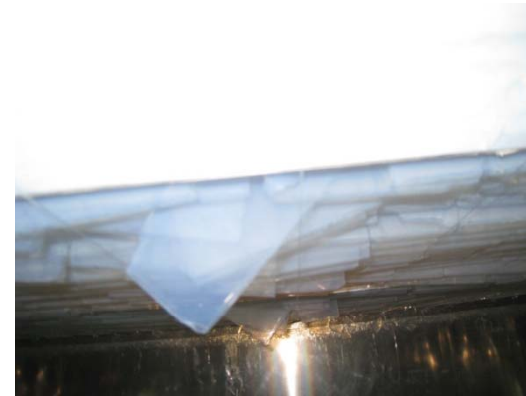
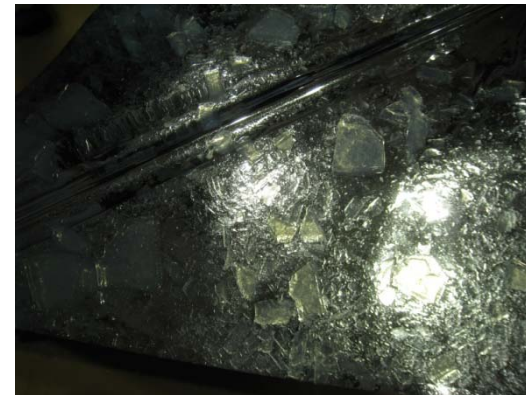
AC was moved much due to the poor supporting and fixing structure. Some of radiators ( 11 cm x 11cm x 2cm ) were broken or slipped. But no serious damage.

**AC was already repaired and is ready to install.**
