T2K status 1

Takashi Kobayashi
IPNS, KEK

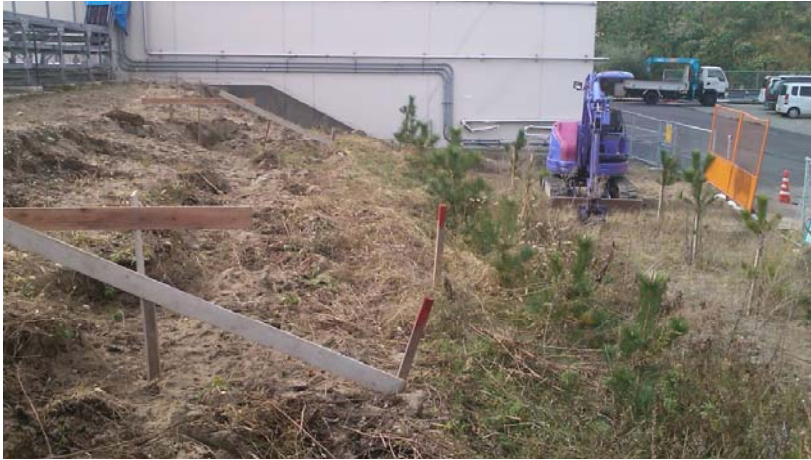
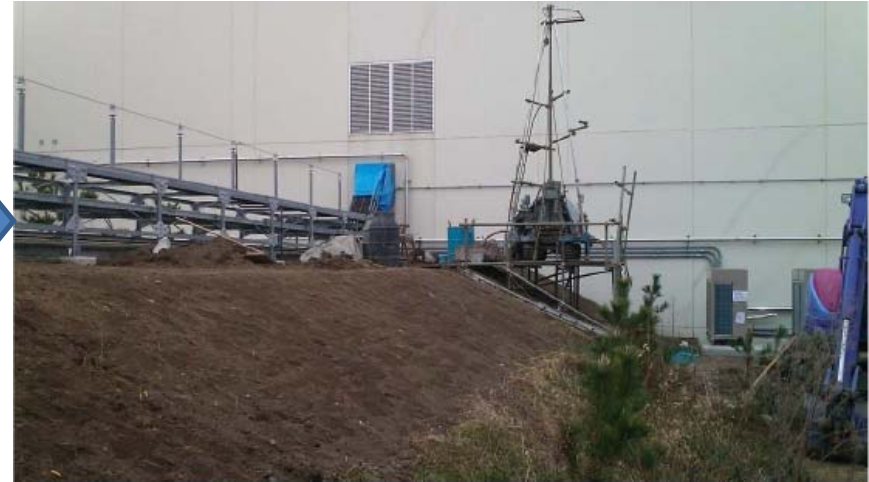
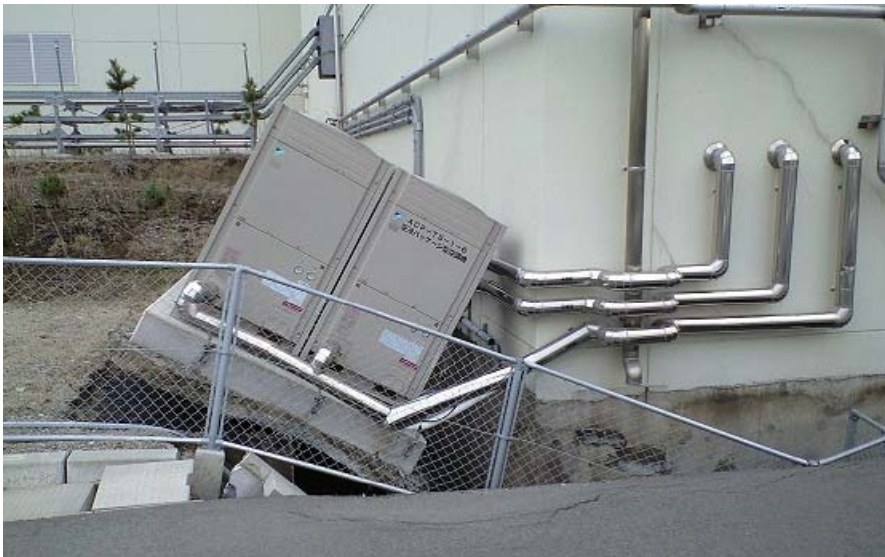
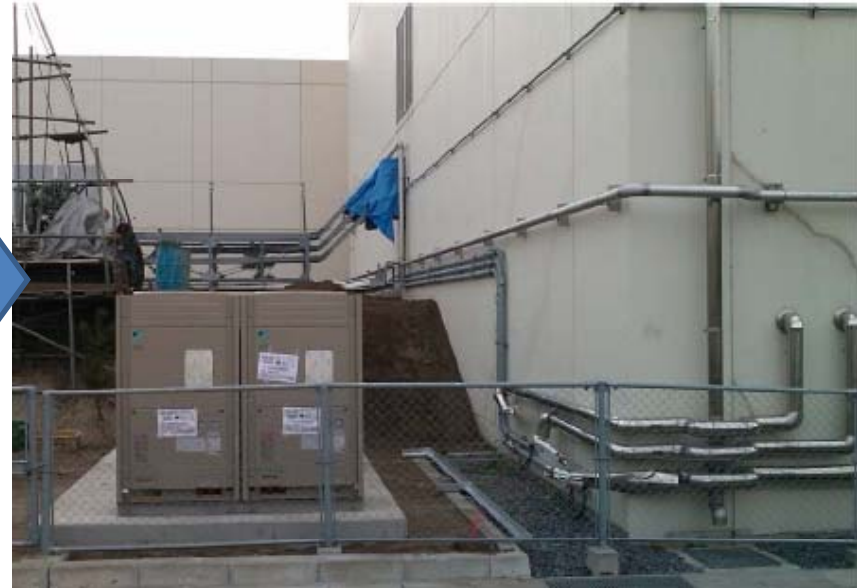
Around target station

- Everything necessary for beam operation were recovered before the scheduled beam on Dec. 24
 - Ground drop around TS and BD were backfilled (paving remains)
 - All magnets in primary line including SC mags were realigned
 - Parts submerged under the water were repaired or replaced
 - 3rd horn was once extracted, visually inspected, alignment was confirmed and reinstalled
 - Target and 1st & 2nd horn were not extracted
 - Position was measured at horn supporting structures and realigned. The alignment was also checked by lowering laser marking device

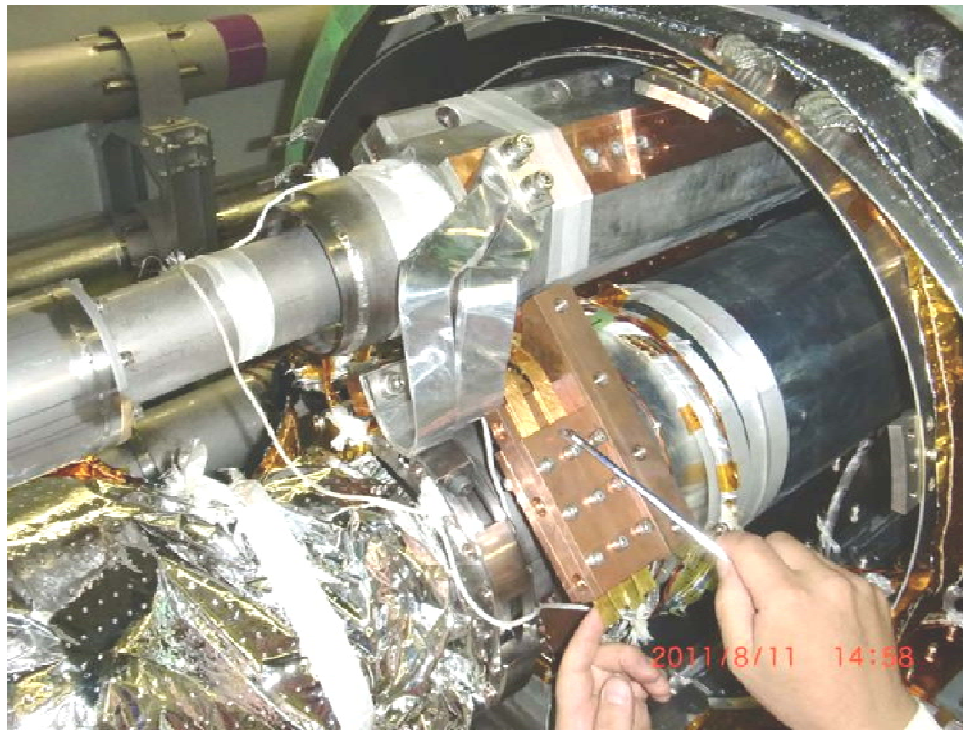
- Cryogenics system worked successfully in May.
- Excitation test was done successfully in May.
- Alignment Done in Aug. Re-survey performed.
- Corrector magnets already repaired.
(Additional heat anchor installed.)

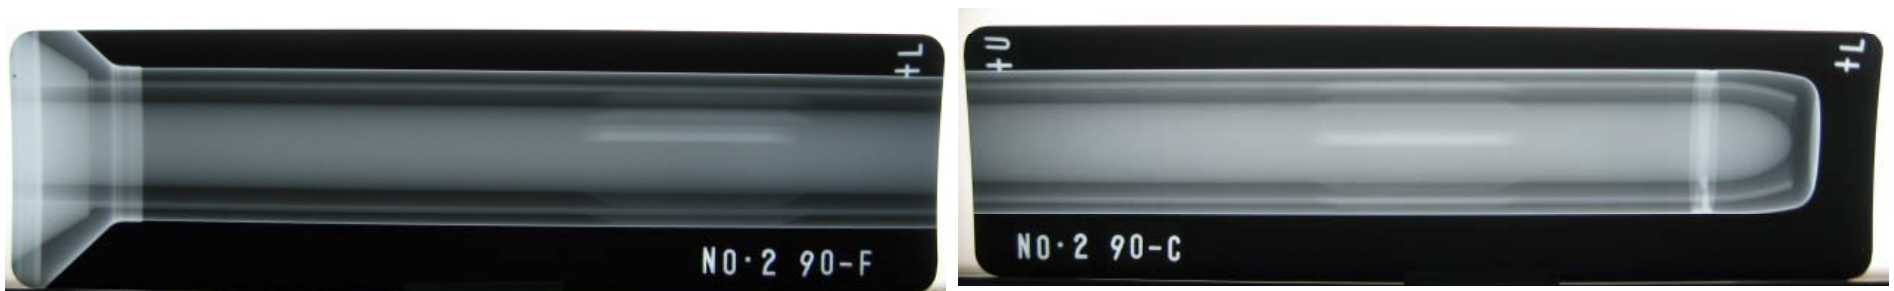
- Installed target
 - No clear change of He flow is found.
 - Spare target No.2(Toshiba) and No. 3(RAL)
 - No damage is found in the graphite parts in X-ray photo.
 - Spares were at TS ground floor at the earthquake.
 - They were also supported as cantilever.
- No indication of the damage of the installed target is found, though we have only circumstantial evidence.

X-ray photograph of No. 2 target

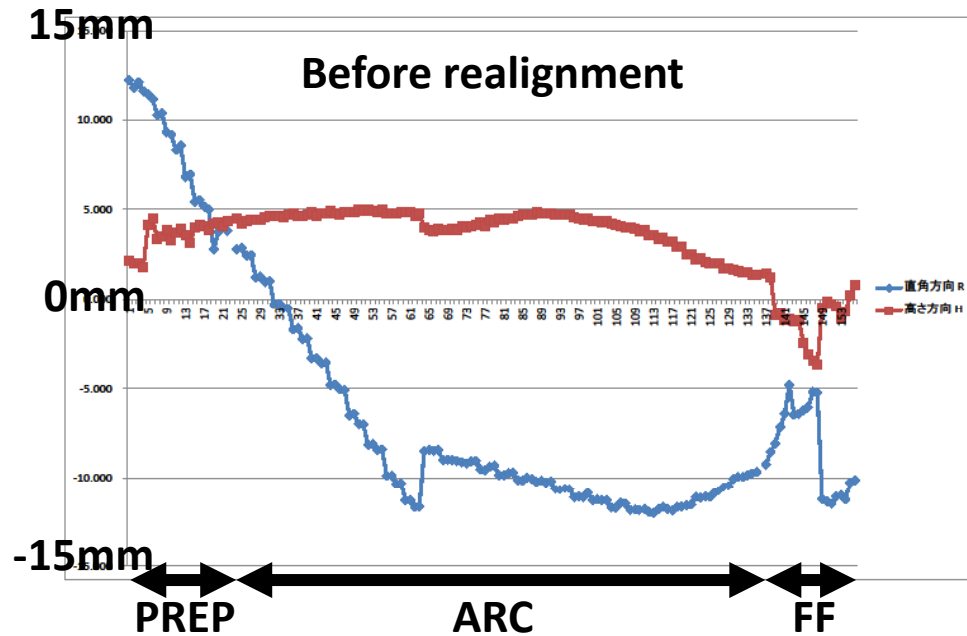
Magnet location [measured – design]

Realignment was done based on the May 2011 survey results. The beam orbit was also redesigned.

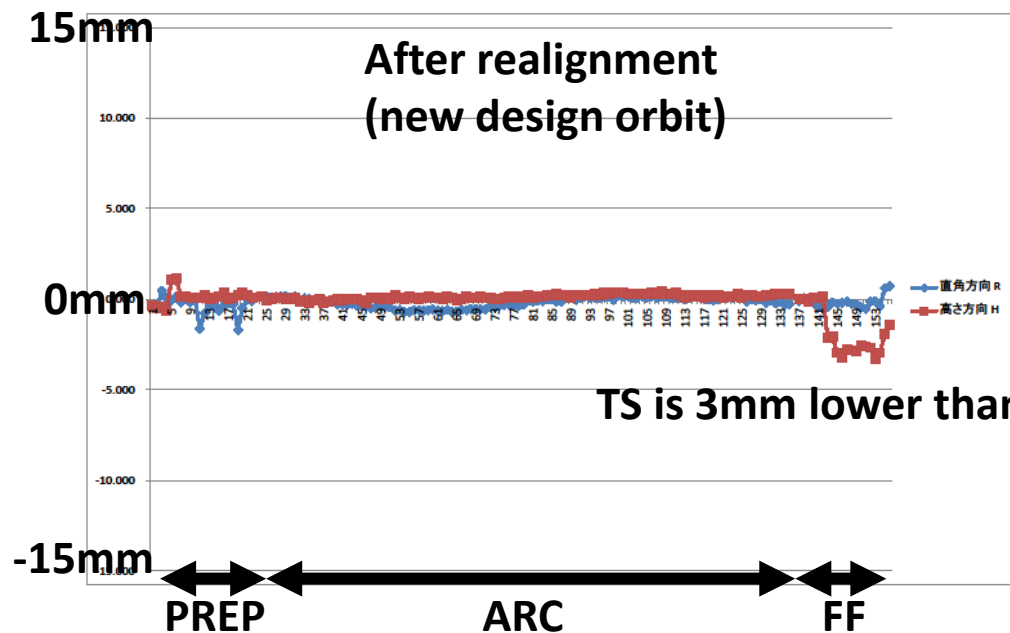
TS is 3mm lower than FF.

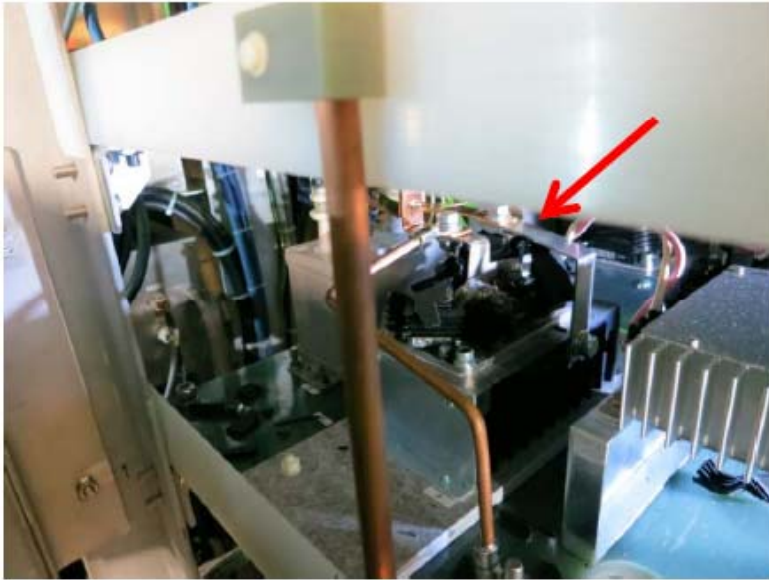
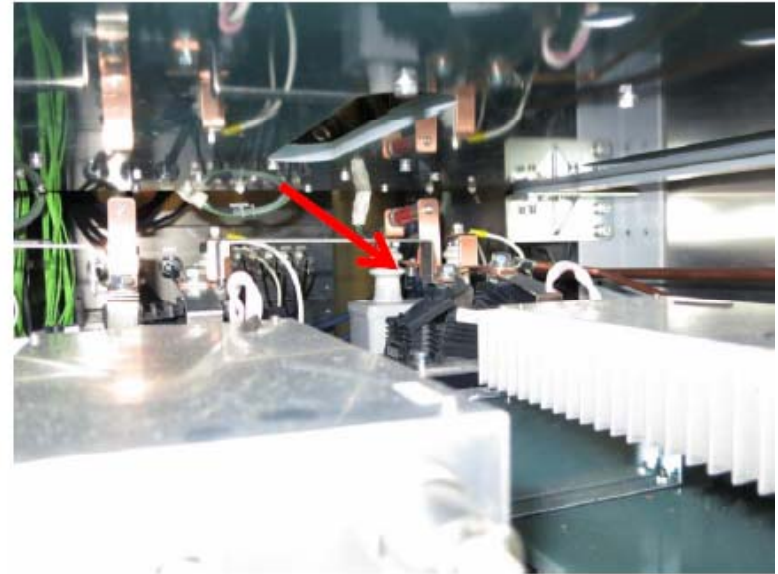
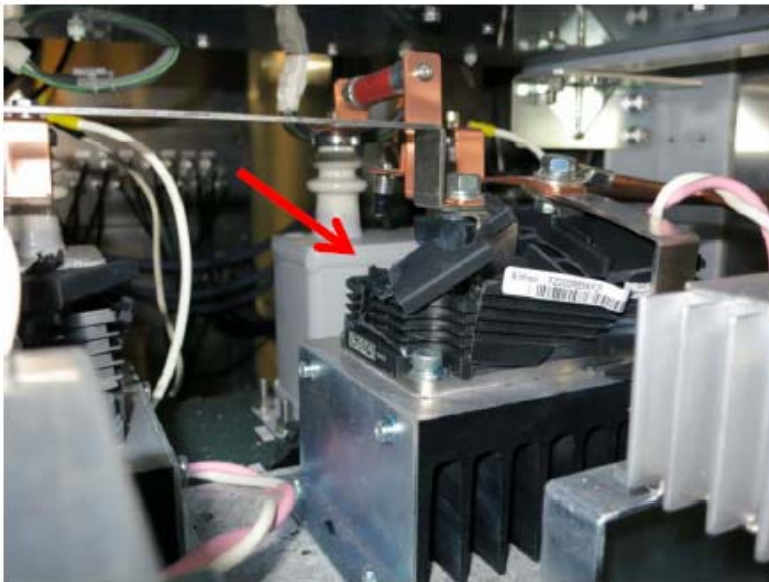
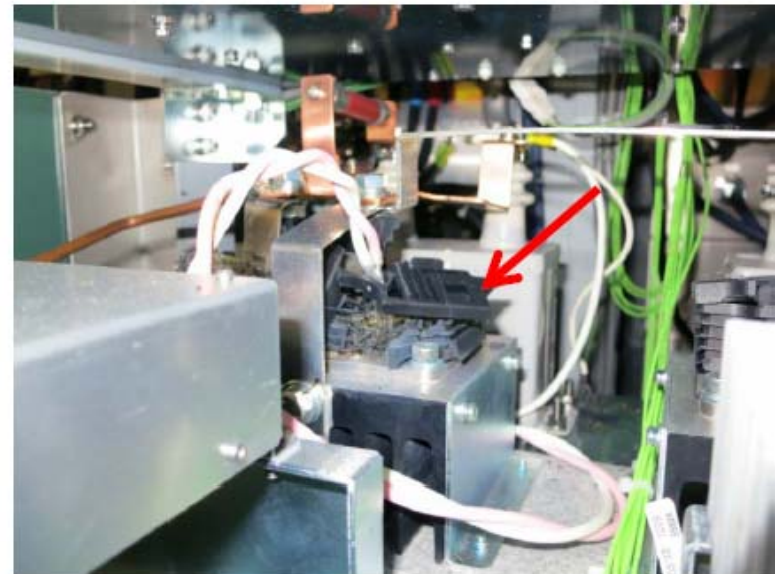
- On Dec. 22, during final operation test, horn power supply was broken
- Several IGBTs to switch charging capacitors were burst
- From visual inspection,
 - Several out of 12 IGBTs are apparently broken
 - It is natural to consider that remaining IGBT are also damaged
 - Choke coil next in serial to IGBTs are also damaged
 - Unexpected huge current went through IGBT
- The reason why such huge current was drawn is now under investigation
 - Control circuits confused by some electrical (spike?) noise issued “switch on” signal to IGBTs at the timing when huge charge is stored in Capacitor bank?
 - Deterioration of IGBTs?

- Recovery: 2 methods in parallel
 - 1.Repair present power supply
 - We have no spare IGBTs with same spec
 - It takes several month to procure
 - We use lower HV rating IGBTs (3.3kV instead of 6.5kV)

- J-PARC MR group has enough stocks. So immediately available
 - May limit current < 250kA (need to check with test operation)
 - 2.Revive old power supply

- Had been disassembled and stored at Tsukuba for ~yr
 - Need to check healthiness
 - Have never driven 3 horns with 1 power supply
 - May limit current <250kA or rep rate (simulation says OK)
